Deterioration mechanisms of historic cement renders and concrete

Isobel Griffin. MA (Hons)

A thesis submitted to the University of Edinburgh
for the Degree of Doctor of Philosophy

July 2013

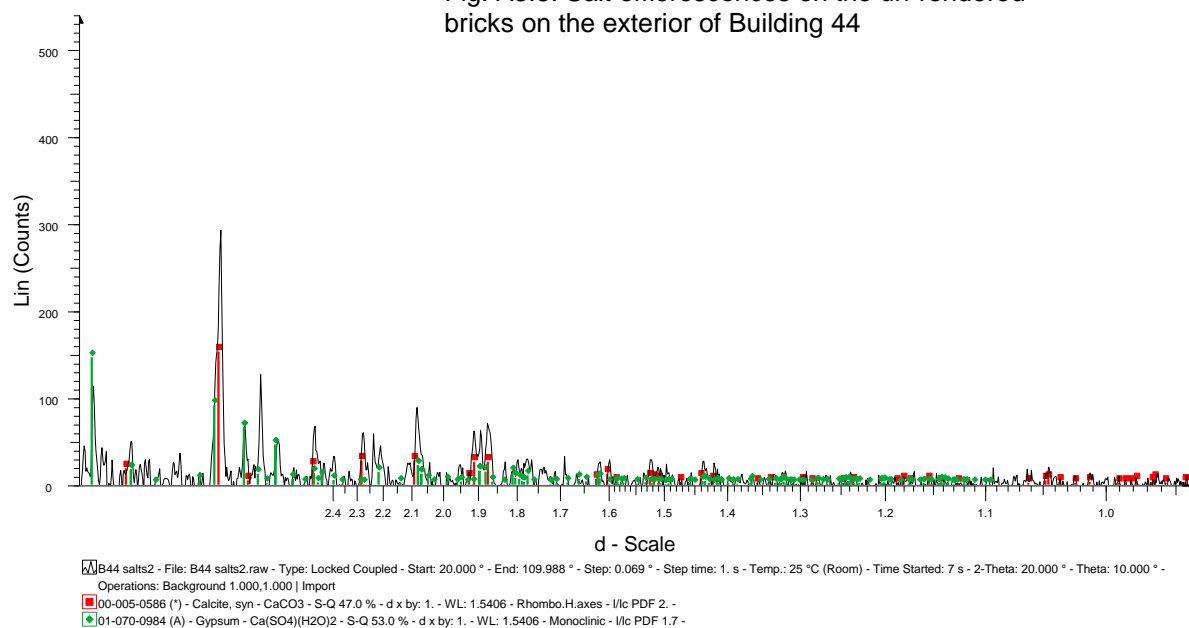
Fig. A3.5. Salt efflorescences on the un-rendered bricks on the exterior of Building 44
